NAVAL POSTGRADUATE SCHOOL

THE MITIGATION OF RADIO NOISE AND INTERFERENCE FROM ON-SITE SOURCES at RADIO RECEIVING SITES

November 2009

3. REPORT TYPE AND DATES COVERED
Handbook

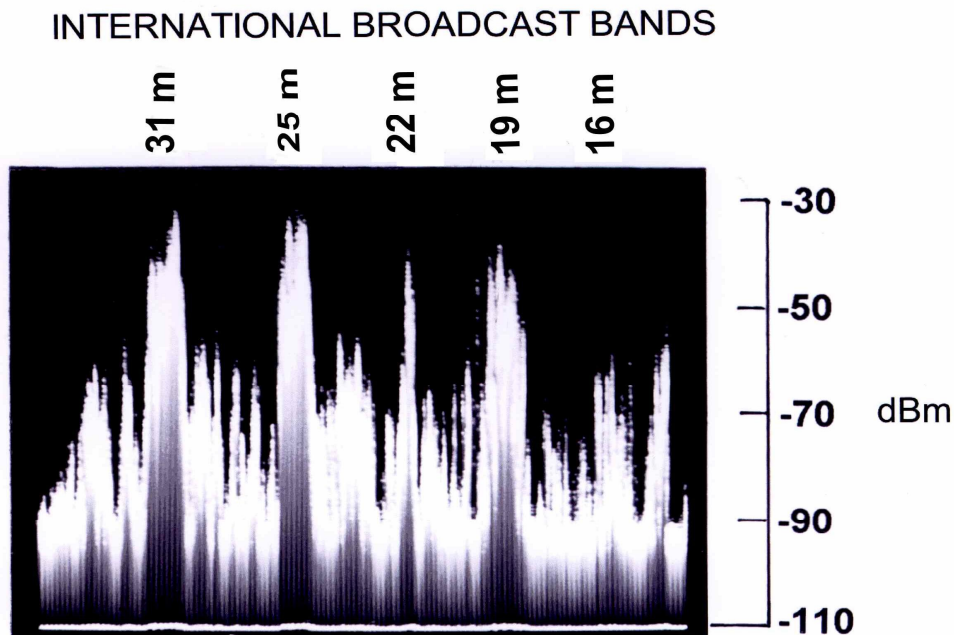
Figure 2 Example of Daytime Signal Levels in the HF Band

At nighttime when ionospheric absorption is low, HF signals will be 30- to 50-dB higher in amplitude than shown in Figure 2.

Similar signals levels can be found at other HF receiving-sites since the distribution of transmitting sources is widely spread around the earth. Only minor site-to-site variations have been noted during measurements at more than 40 radio-receiving sites.²

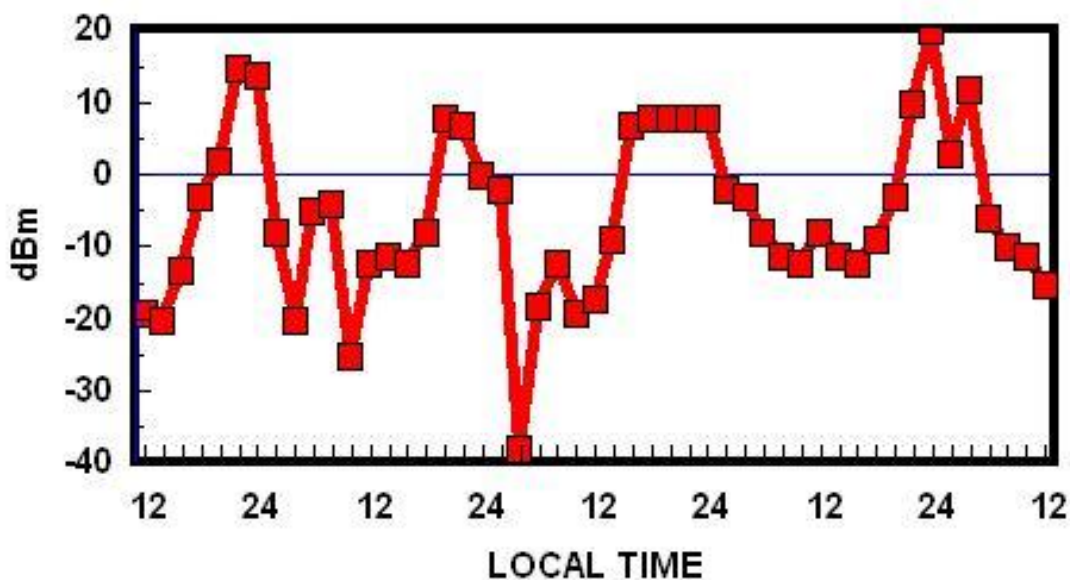
Figure 3 Diurnal Variations in Total HF Received Signal Power

Most HF and VHF/UHF receivers are capable of detecting a signal as low as -130 dBm in a 3-kHz bandwidth. This indicates that a broadband dynamic range of about 100 dB is required for all components in the RF distribution path during the daytime and up to about 140 dB at the nighttime hours. Any linear component in the RF-distribution system and in the broadband portion of a receiver that does not have this dynamic range will saturate and cause excessive intermodulation products and intermodulation noise which will appear at the input terminals of the receiver. Since the needed dynamic range is extremely difficult to achieve in standard broadband amplifiers and in receivers, automatic gain control is often used to limit the operating range of amplifiers and receivers at the expense of losing low-level signals.

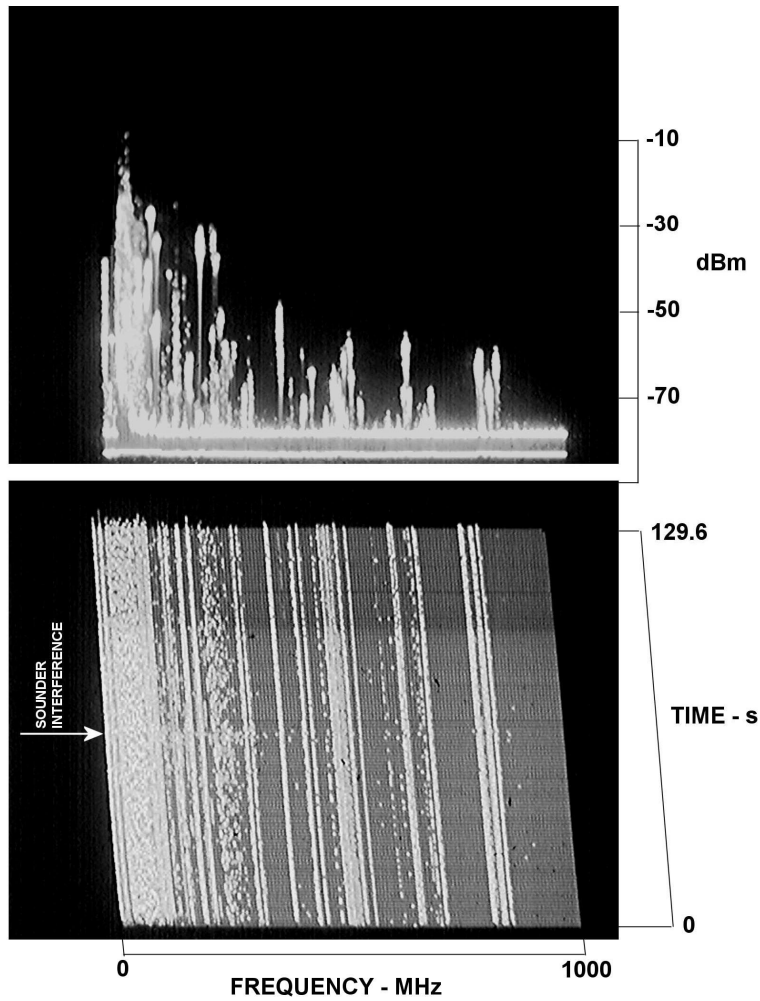
K-VHF, 28A/29A, 080923, 1421, 500, 1000, 30, 1000, A1-V, NF, 0, 0, -10
SOUNDER AT 15 WATTS

Figure 4 shows a typical example of signal levels in the VHF band. In this case the primary strong sources are FM and Television stations located on nearby hill or mountain tops that are within line of sight. Occasionally one will encounter strong signals from other nearby sources such as mobile or fixed communications sites.

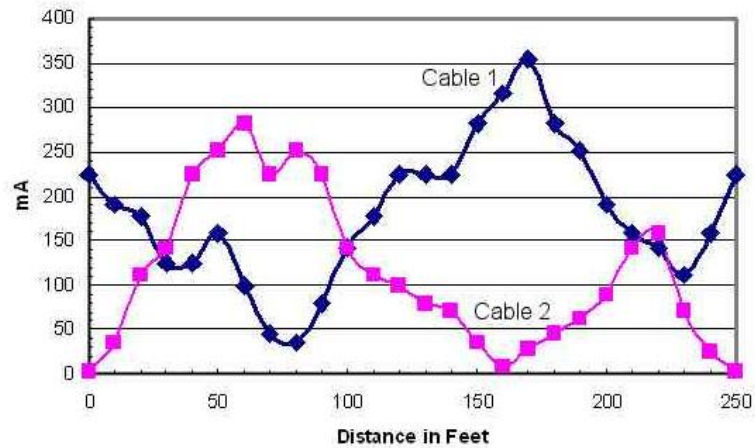
Figure 6 Variation of EMI Current Level on Cable Shields with Distance

frequency of 2 MHz, and the shield current was measured at 10-foot intervals along the cable. The dark line on the plot of Figure 6 shows the current magnitude along the length of Cable 1. The distinctive standing waves on the cable shield are identical to those along a long-wire antenna.

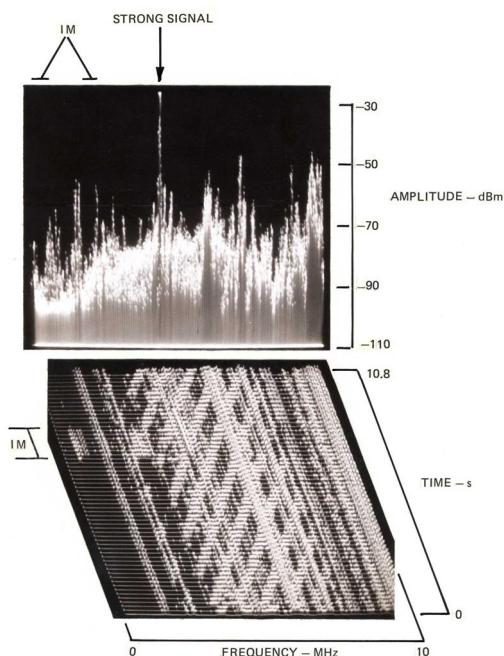
Figure 7 In-Band IM Noise

Figure 7 shows a brief burst of intermodulation noise caused by a strong signal burst that overloaded the amplifier of a multicoupler. Such bursts of IM noise can be similar to some short-duration signals, and when present they put an unwanted burden on a receiving system which must differentiate them from desired signals.

The previous Figure 7 shows one example where a strong signal about one-second in duration produced IM products and noise also about one-second in duration. Even shorter duration IM products and noise can occur, and Figure 9 shows an example. In this case a frequency-hopping transmitter emitting pulses in the low portion of the VHF band was operated adjacent to a receiving facility. Its strong VHF signals overloaded components in the RF path and produced high-level impulses of IM noise from 60 MHz up to 1000 MHz. Figure 9 shows an example of the resulting IM pulses in a 10-MHz wide portion of the radio spectrum centered at 309 MHz.

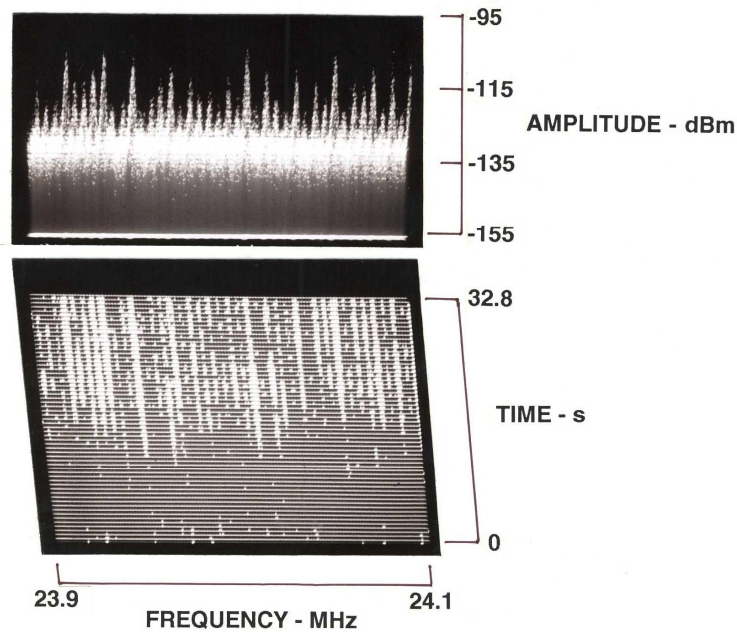
HAN, PASTEUP, 930930, 0130, 24, 0.2, 1, 500, A30, BPF (2-30), 38, -10, -20

Figure 8 shows another example of interference caused by saturated components in an RF path to a receiver. Multiple high-level signals from international broadcast stations in the HF band exceeded the dynamic range of a component in the RF path and caused the closely-spaced IM products. In this case the broadcast signals were all below the frequency range shown. Ionospheric propagation limitations prevented normal signals from being received within the frequency range of the example at the time of day of the example, thus all of the spectral components in the view are IM products. The reduction in amplitude of the IM products in the lower one-third of the time-history view is because of fading of the ambient signals that overloaded the RF components. The maximum amplitude of the IM products is shown in the upper amplitude-vs.-frequency view. Additional IM products also existed at lower and higher frequencies, including the lower frequencies where the broadcast signals were received.

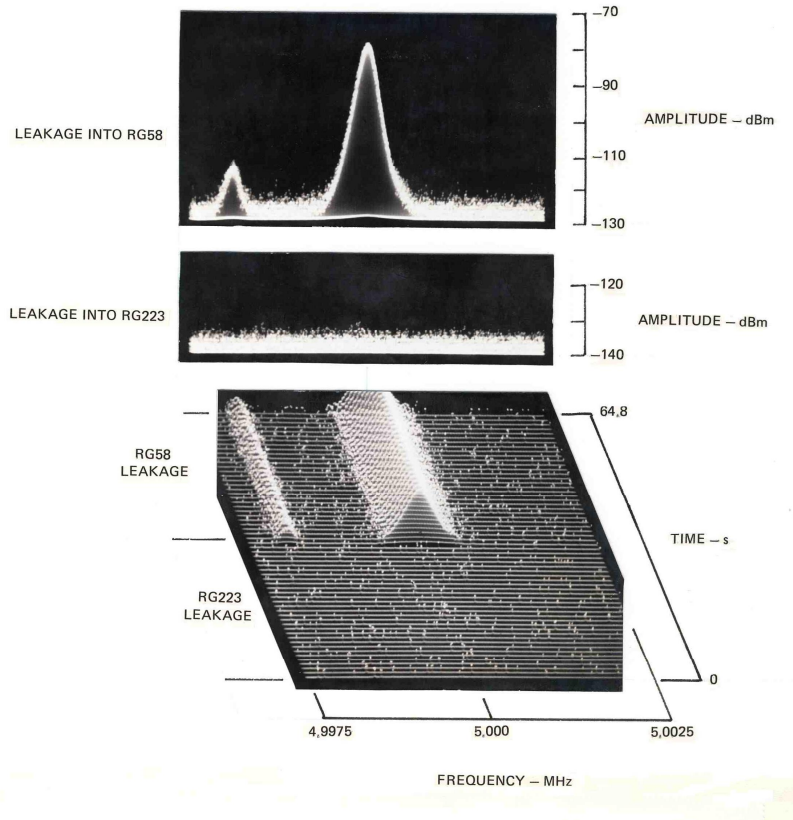
Figure 10 Example of Leakage into Coaxial Cables

Figure 10 shows an example of severe leakage encountered at a receiving site. In this case a 5-MHz frequency-reference signal was distributed throughout the site over single-shielded RG-58 coaxial cable⁷. Radio signals were carried from the entry into the building and to receivers on single-shielded cables. Leakage of the reference signal and a second lower-level signal into a single-shielded cable feeding the receiver was exceptionally high. Of interest was that no detectable leakage was found in a parallel double-shielded coaxial cable feeding another receiver. This example clearly indicates that the use of single-shielded coaxial cable in a receiving site must be prohibited.

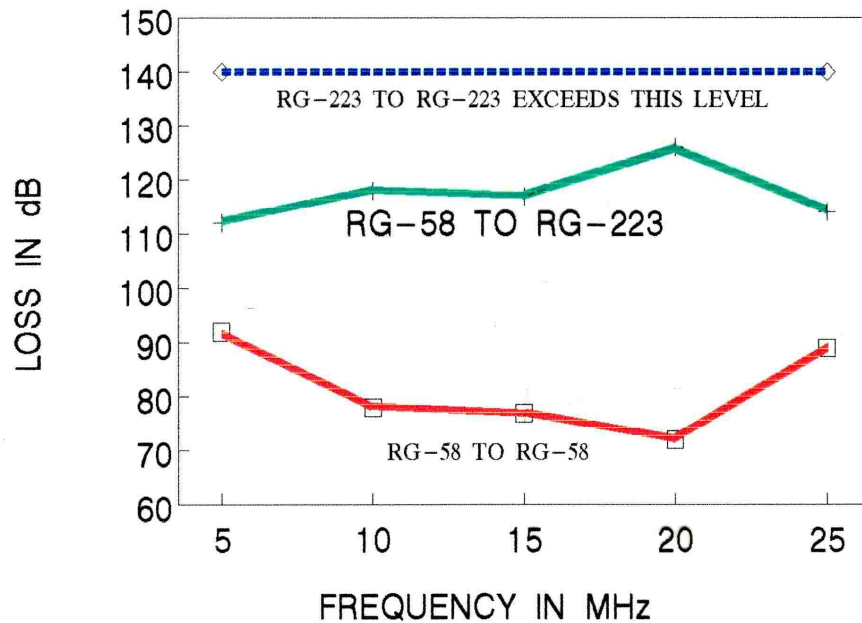
Figure 11 Cable-to-Cable Coupling Loss

To better understand the leakage of signals from one cable to another, two single-shielded cables (type RG-58) fifty feet long were run in a straight line along the earth. Two fifty-foot double-shielded cables (type RG-223) were added to the configuration.

Test signals were first injected into one of the single-shielded cables and then into one of the double-shielded cables. The far end of each driven cable was terminated in a fifty-Ohm coaxial terminator. The far ends of the un-driven cables were also terminated with 50-Ohm terminators, and the signal levels that leaked into the un-driven cables were measured with a spectrum analyzer at frequency intervals from 5 to 25 MHz.

Figure 11 shows the result of this measurement where the leakage loss is expressed in dB. The single-shielded to single-shielded coaxial cable provided only about 70 dB of isolation near the center of the frequency range while the double-shielded to double-shielded loss was greater than 140 dB (not measurable with the test setup available). The single-shielded cable to single-shielded isolation is clearly insufficient to provide acceptable signal isolation from one antenna cable to another since at least 130 dB of cable-to-cable isolation is needed to avoid cross talk of received RF signals. The isolation provided by single-shielded to double-shielded cable also did not meet the needed isolation levels. Because of these findings only double-shielded coaxial cable should be used throughout a receiving site.

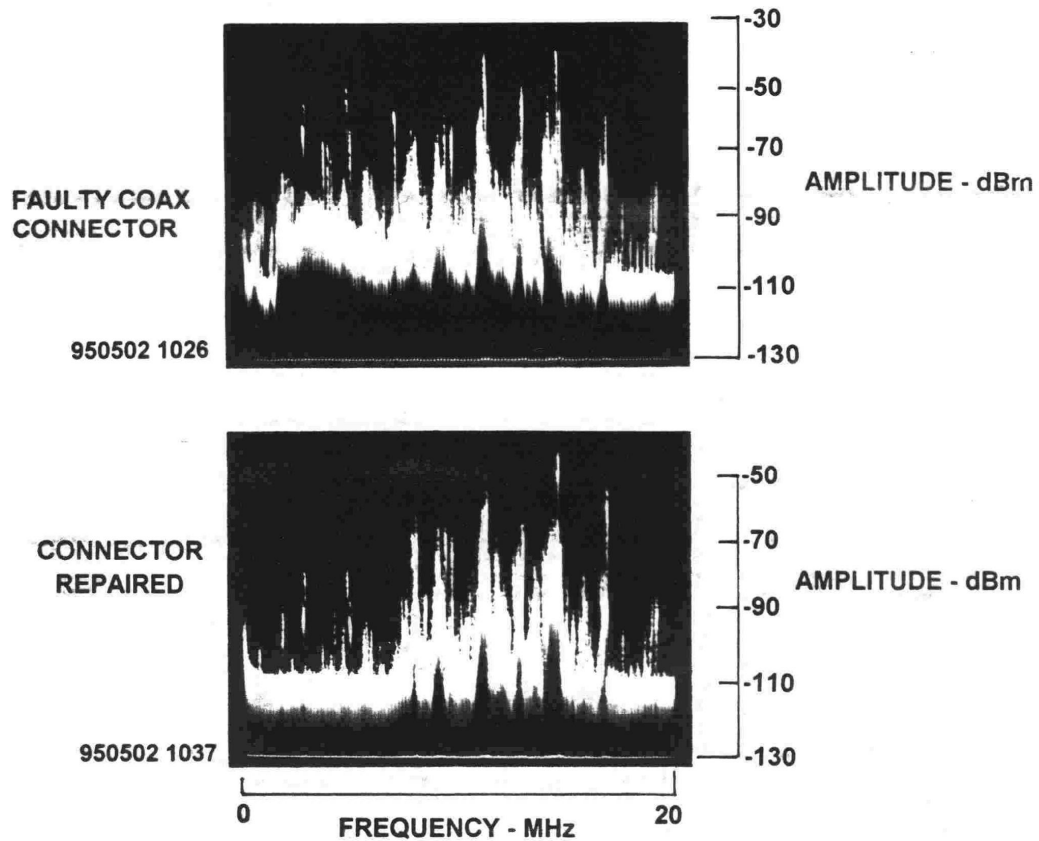
SAB, 950502, 1026/1037, 10, 20, 3, 2000, HF OMNI, NF, 0, 0, -50

The upper view of Figure 12 shows signals and noise at the input terminals of a receiver when an improperly assembled coaxial connector was installed on a coaxial cable in the RF-Distribution path for that receiver. The shield of the cable was open at one end enabling EMI current and voltage on the cable shield to enter the signal path. The noise floor over the low-frequency portion of the frequency range is excessively high. The lower view shows the reduction in the noise floor when the shield was properly connected.

Figure 12 Impact of Improperly Assembled Coaxial Connector on Noise Level

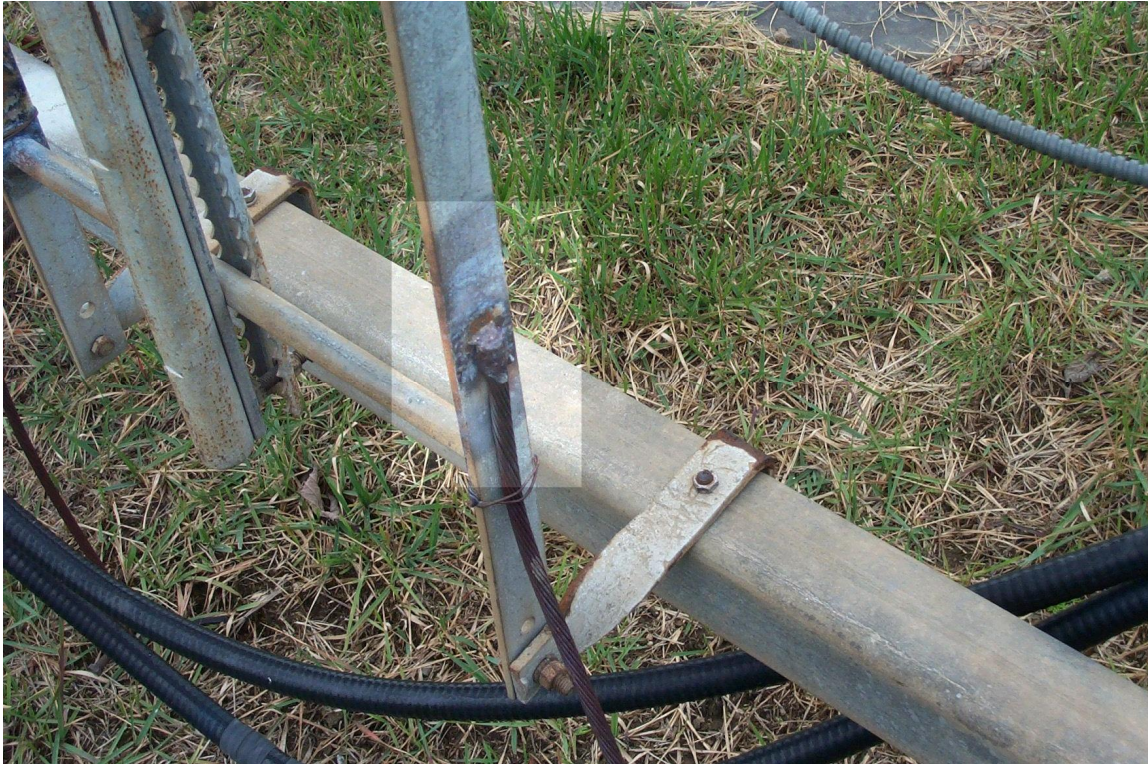
Figure 14 Ground Wire Welded to Galvanized Metal on Antenna Tower

Figure 14 shows a ground conductor welded to a galvanized metal component of a tower at a receiving site. This tower was adjacent to the tower shown in the previous figure. The weld was clearly of poor quality, and it was necessary to use a tie wire to maintain its mechanical properties. In addition to its ability to produce intermodulation products and broadband intermodulation noise, the poorly welded joint would be blown free of the tower from surge current induced by a lightning strike.

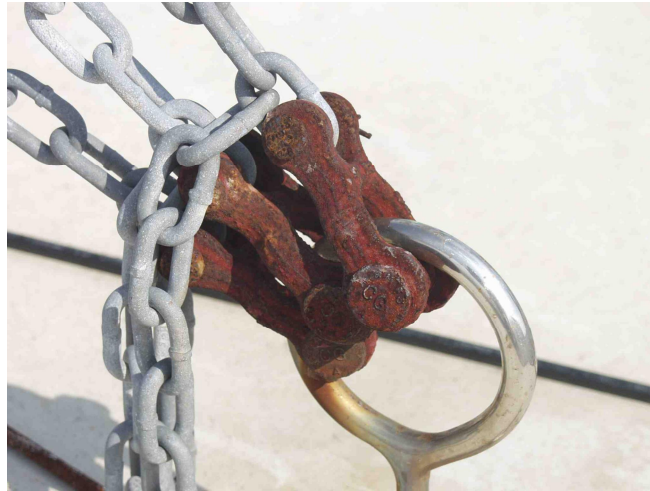
Figure 16 Example of a Rusty Joint

The rusty joint effect is well known to old-time radio engineers, especially when the rusty joint is in the antenna system. Figure 16 shows an example of such a joint that was part of an antenna guy. Also of concern is the use of chain in the guy because its joints can move from wind resulting in intermittent contacts. A thin layer of insulating oxide is formed on galvanized metal, and wear from movement can intermittently make and break through the layer. Non-conducting line should be used for all antenna guy material or metallic guys with properly installed and spaced compression insulators.

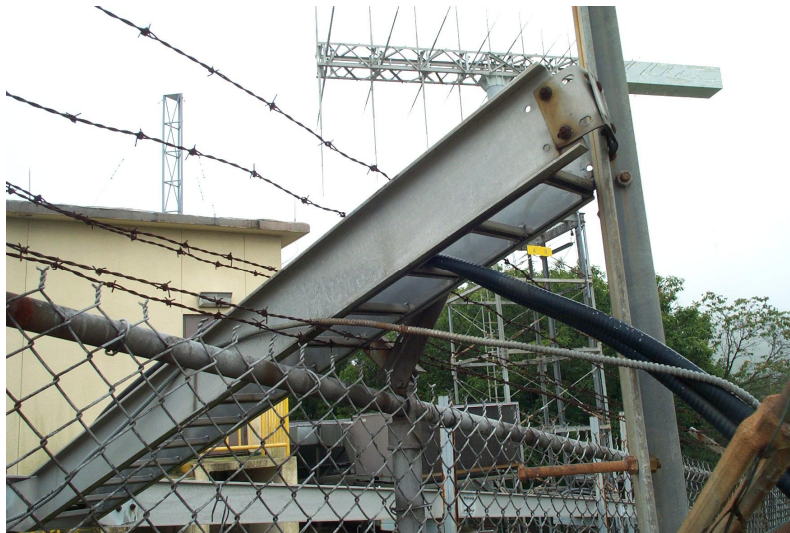
Figure 17 Example of Incidental Contacts

Figure 17 shows an example of multiple incidental contacts between conductors where the conductors are physically and electrically close to receiving antennas. Low-level standing waves of current and voltage exist on such conductors from ambient radio signals. The intermittent contacts formed by minor movement of the conductors result in impulses due to small potential differences between the conductors. These low level impulses radiate and result in low-level and erratic impulsive noise at the input of the site's receivers.

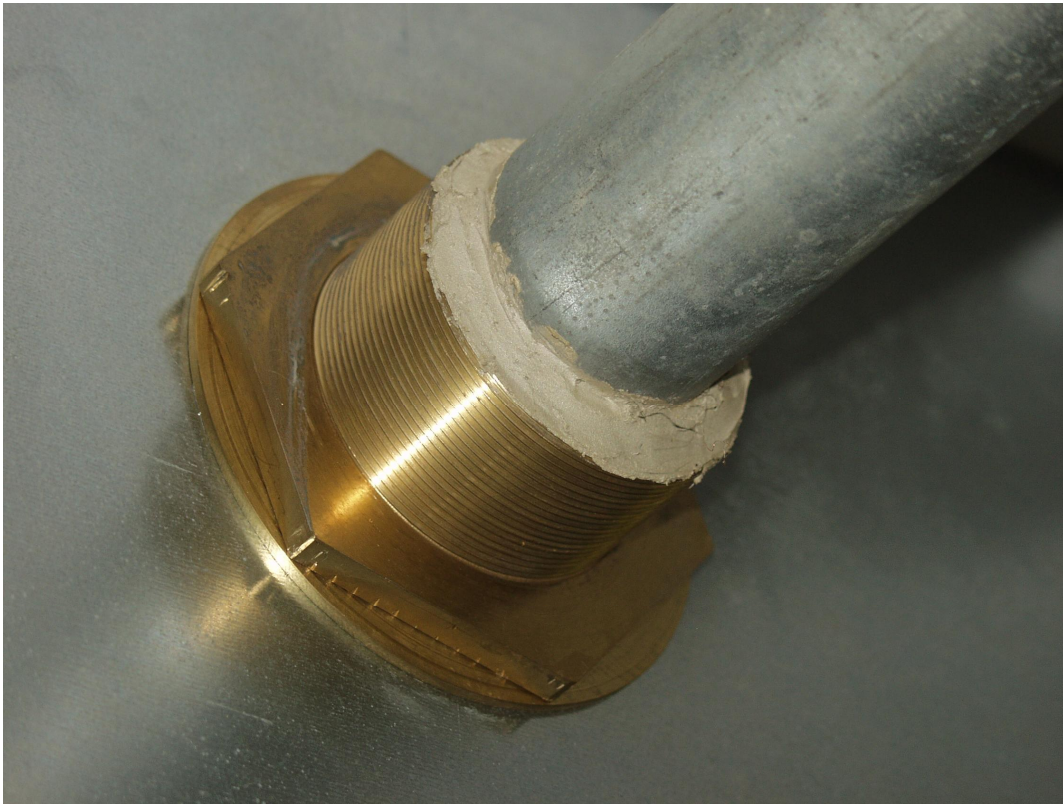
Figure 18 Water Pipe Penetrating a Shielded Room

A few common examples of problems with shielded rooms are shown in this section. The technical details associated with the use of small and large shielded spaces are presented in more detail in Section 7. Figure 18 shows where a water pipe penetrated a wall of a shielded room. This pipe can conduct EMI current and voltage from outside sources into the room, and it can conduct EMI current and voltage from sources in the room to locations outside the room. The outside surface of the water pipe should be electrically connected to both sides of the shielded-room wall. This provides a low-impedance path for EMI current to flow back to its source rather than into or out of the shielded room.

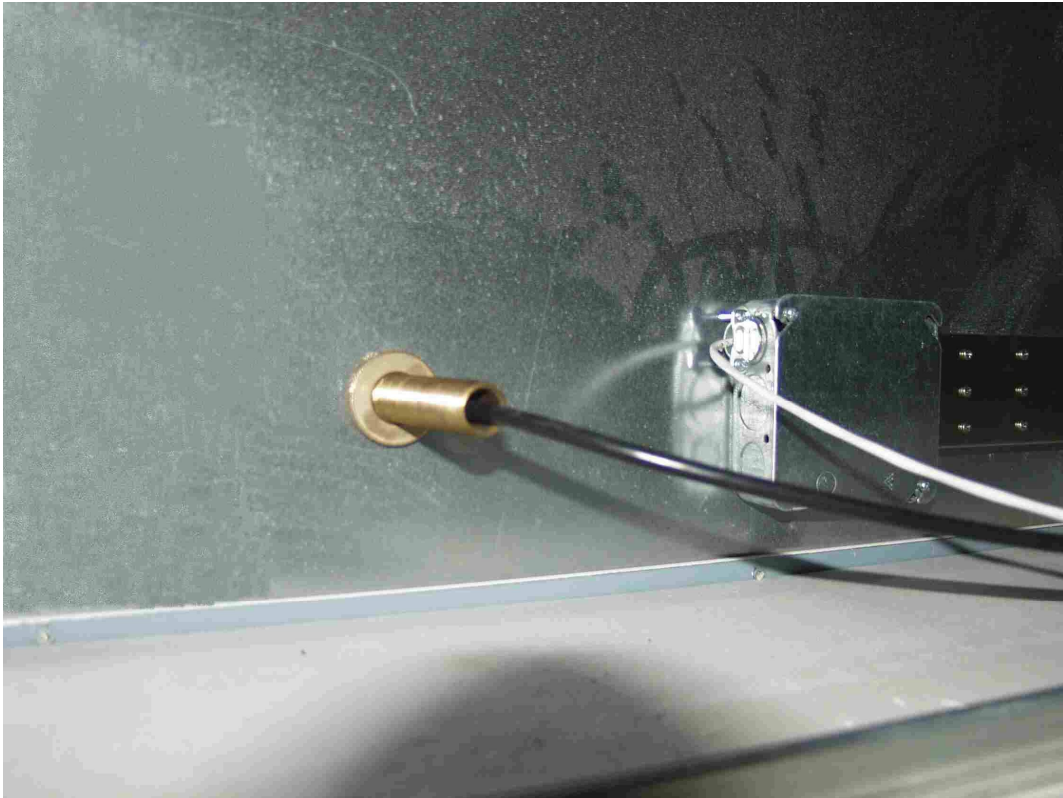
Figure 19 Coaxial Cable Penetration of a Shielded Room

Figure 19 shows another penetration of a shielded room. In this case a coaxial cable associated with the site's security system penetrated the shielded room. Its shield carried EMI current and voltage into and out of the shielded room. This kind of conducting penetration must be avoided since a single such penetration as shown can completely destroy the effectiveness of a shielded room. In this case a standard coaxial bulkhead connector at the penetration point would have provided a satisfactory means of terminating the cable shield on both sides of the wall of the shielded room.

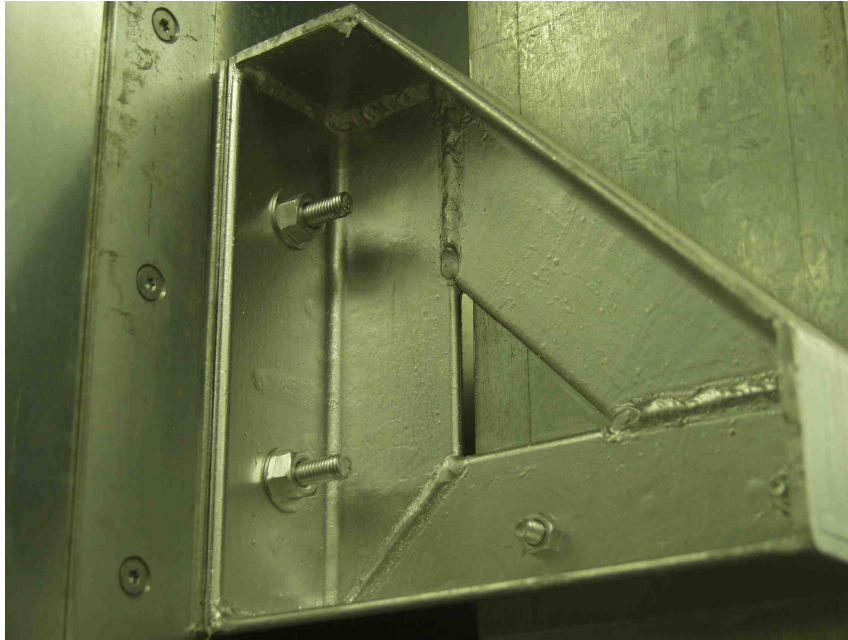
Figure 25 Weld on Galvanized Steel inside a Radio-Receiving Building

In addition to the above items, other building issues that impact the operation of a radio receiving site can exist. Figure 25 shows a support bracket fabricated out of galvanized steel and bolted to the side of a shielded room. This bracket was welded after galvanizing. While it provided excellent mechanical support, EMI current was flowing on the surface of the shielded room and such current passed through the nonlinear joints of the welds. The resulting harmonics, IM products and IM noise generated by the nonlinear joints added significantly to the RF environment inside the room which contained RF cables, RF preamplifiers and other low-level radio systems.

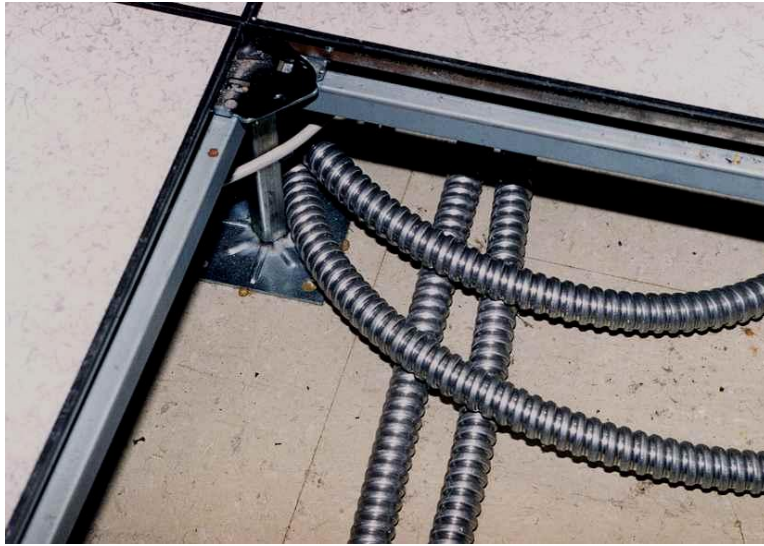
Figure 26 Incidental Contact, Example 1

Figure 26 shows a photograph of unwanted intermittent contacts. MC cables providing power to electronic devices were in loose contact with each other. Also two of the cables were in intermittent contact with a metal floor stanchion. Unfortunately, the MC cable shields carried significant levels of current at harmonics of the electric power, and a person walking on the floor above can cause sufficient movement to produce harmful levels of transients.

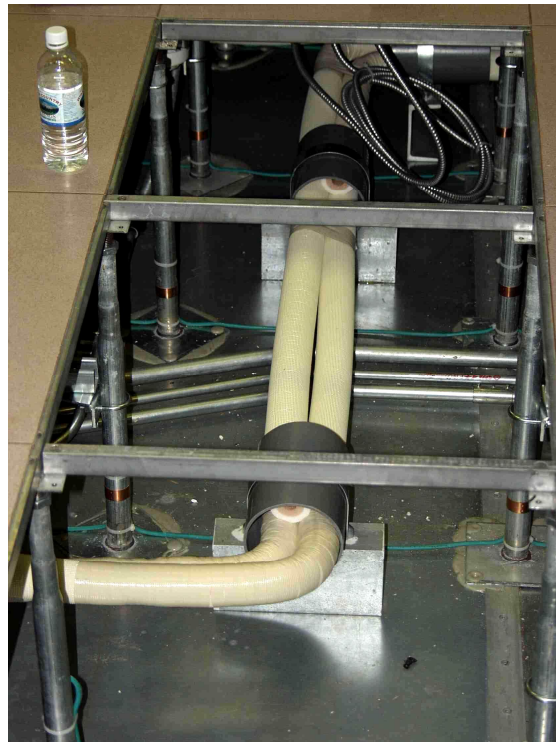
Figure 27 Incidental Contact, Example 2

Still another example of incidental contacts between conductors is shown in Figure 27. In this case an extra length of MC cable was coiled and left under the floor in loose contact with other conductors. It also resulted in unwanted transients when anyone walked on the floor above the cable. Of interest is that the photograph shows that other metal objects were properly bonded together to avoid the production of transients.

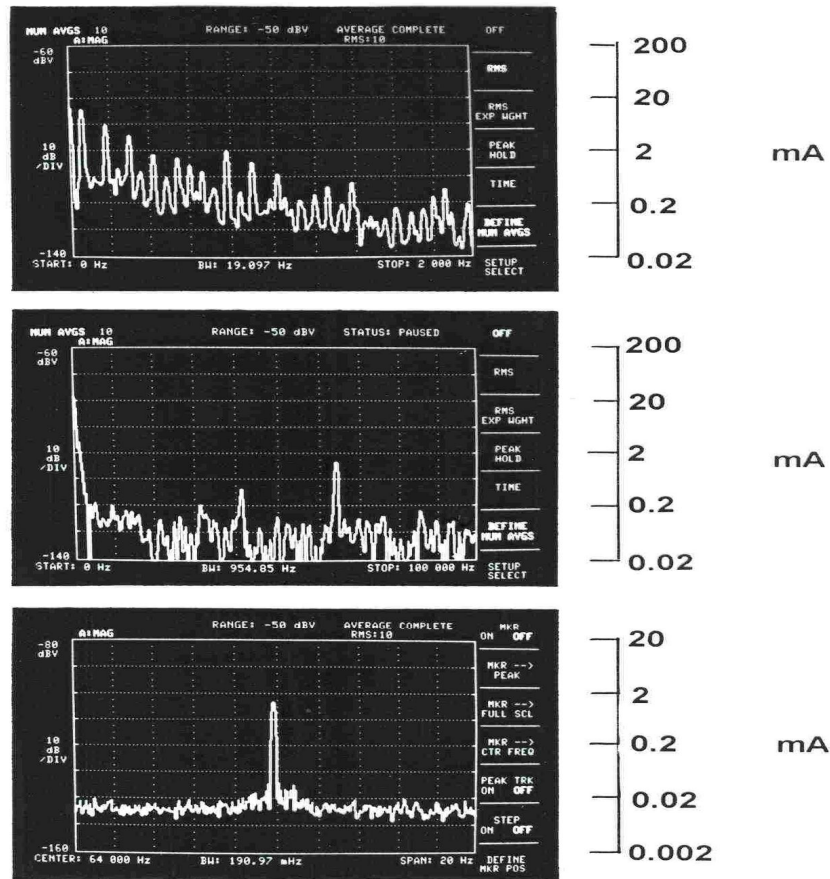
KUN, RM 332, 990212, R408, 1358, CAB GND, CT5 (20/1), P6021 (10mA/mV), 0

Significant levels of low-frequency current at the fundamental and harmonics of the electric-power frequency and at higher frequencies are found on ground buses, conduits, and other conductors of a building. Figure 28 shows three views of spectral components of current flowing on a green-wire ground from a cabinet containing digital devices. The top view shows current at the fundamental frequency and at harmonics over the frequency range of 0 to 2000 Hz. The middle view shows a coarse view of components over the frequency range of 0 to 100 kHz. The bottom view shows an expanded view of a strong component found at 64 kHz. Other cases have shown that 50- or 60-Hz levels as high as 8 A have been found flowing on conduits along with harmonic levels up to 1 A.

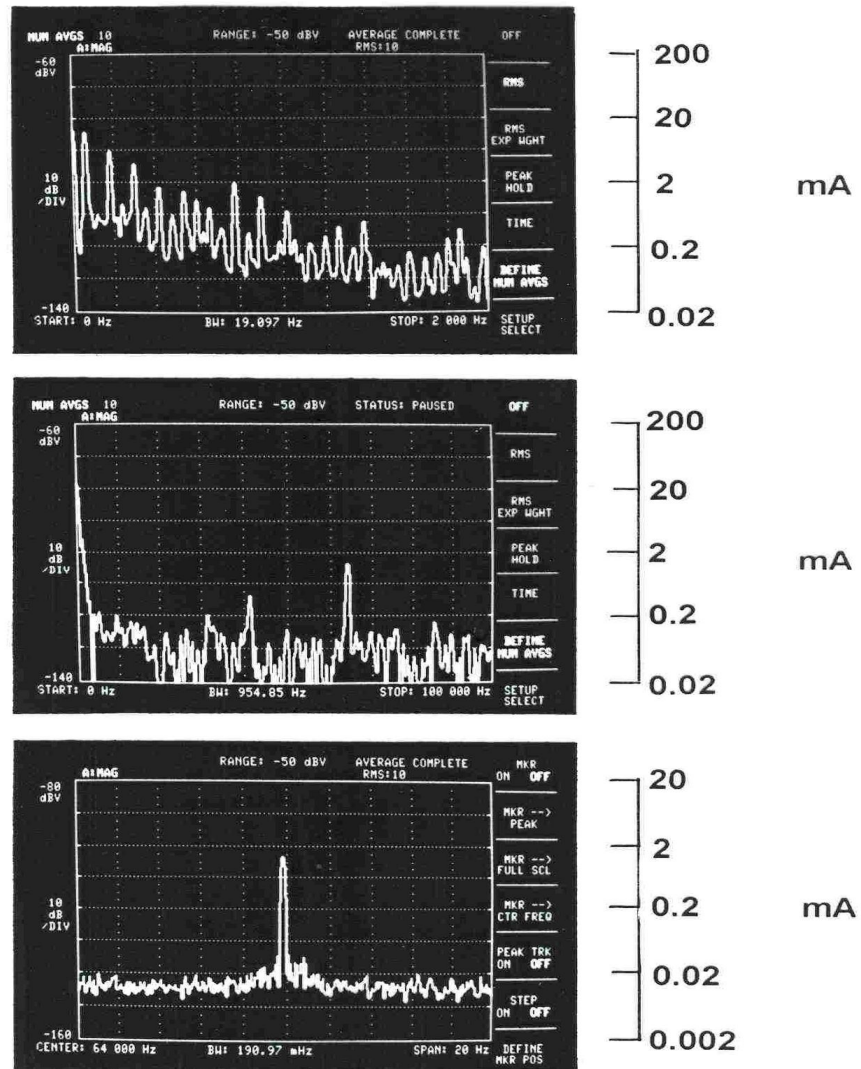
KUN, RM 332, 9902,12, R408, 1358, CAB GND, CT5 (20/1), P6021 (10mA/mV), 0

Figure 29 shows another example of unwanted current flowing on a cabinet ground conductor. In this case multiple and sensitive digital signals appeared on a major ground conductor of a data-processing facility. Further investigation identified the same digital signals on several cable shields and on several other ground conductors. The source was a signal cable whose shield was open at one end. This was done to reduce low-frequency current also flowing on the cable shield to harmless levels, but it allowed the high-frequency digital signals to appear on the shield of the signal cable as well as on other nearby conductors.

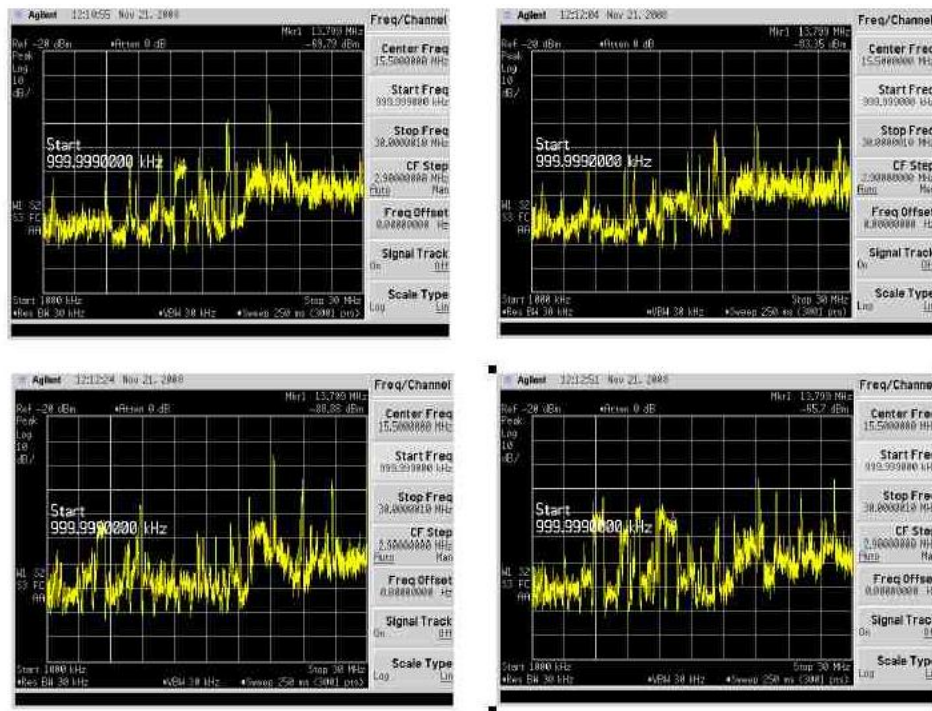
Figure 30 Example of Erratic Noise and Interference

Figure 30 shows an example of erratic noise and interference found over the 1- to 20-MHz portion of the HF band at a receiving site where the data was obtained with a conventional scanning spectrum analyzer. Four sequential scans are shown where the spacing between the first two scans is about 20 seconds, and the spacing between the other examples is only a few seconds. A careful examination of the four examples shows significant differences in detail from one to the next one. The spectral and temporal properties of the noise and interference changed significantly from example to

example, and the changes cannot be understood from such sequential examples. These examples illustrate the difficulty in describing erratic noise and interference with standard instruments.

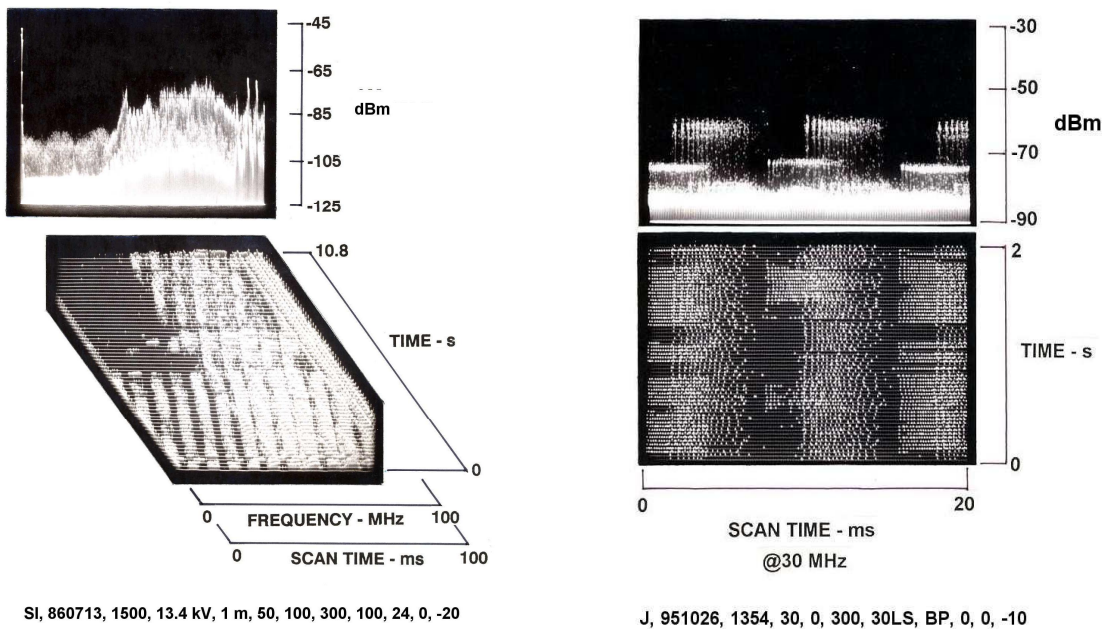
Figure 33 The Complex Structure of Intermittent Power Line Interference

The right figure shows the complex temporal structure of two simultaneous sources. In this case the frequency scan of the spectrum analyzer was set at zero-frequency scan and the scan time was changed to enhance the detail of temporal structure. The amplitude differences of the three sources are shown in the upper view. The two views show the details of the interference at the input terminals of a receiver set at a frequency of 30 MHz.

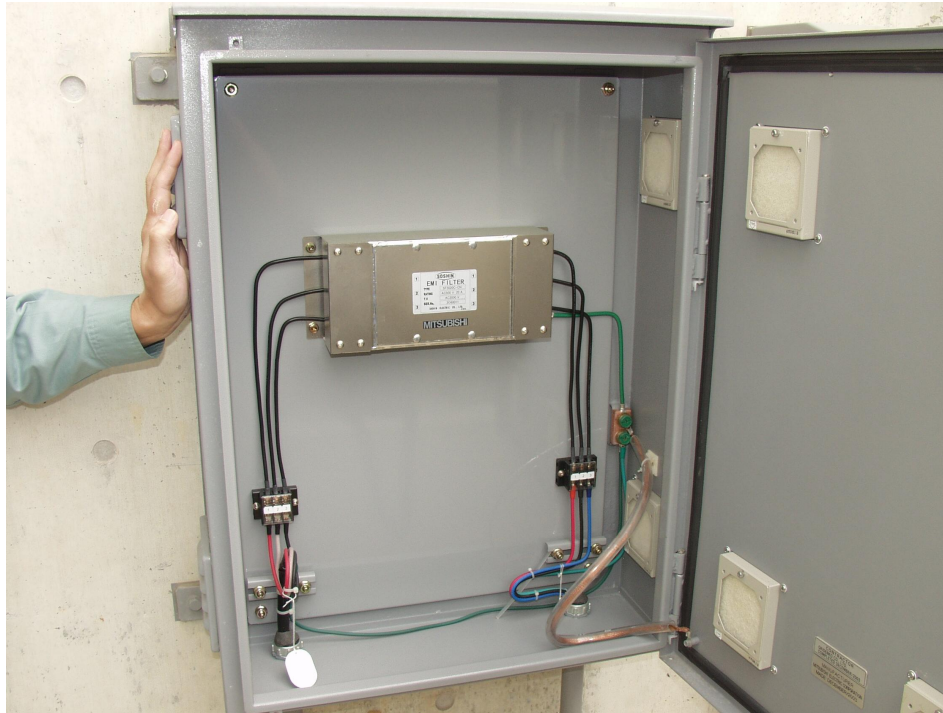
Figure 49 Improper Filter Configuration

Several improper aspects of the filter installation resulted in the total lack of suppression of a severe electromagnetic impulsive noise problem. These aspects were:
